### A "Routine" Incident

# A "Routine" Incident – Aftermath

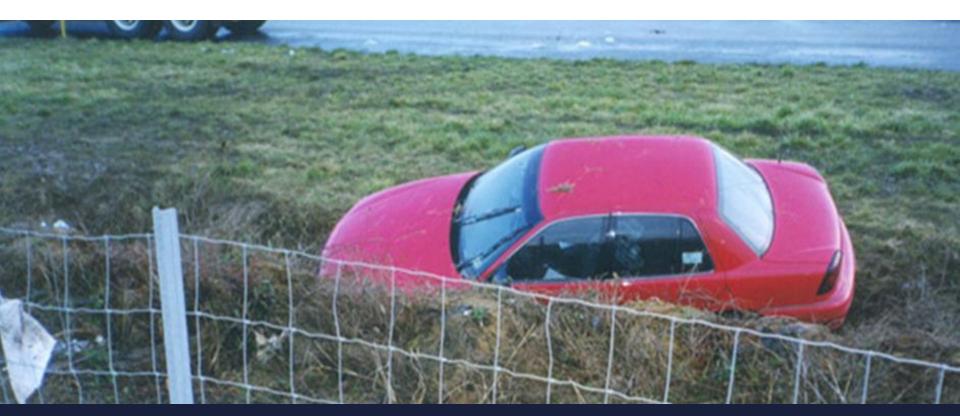
- March 9, 1998 at 2:10 p.m. Raining, wet roadways
- Vehicle on PA Turnpike lost control and slid into a drainage ditch... 911 is called

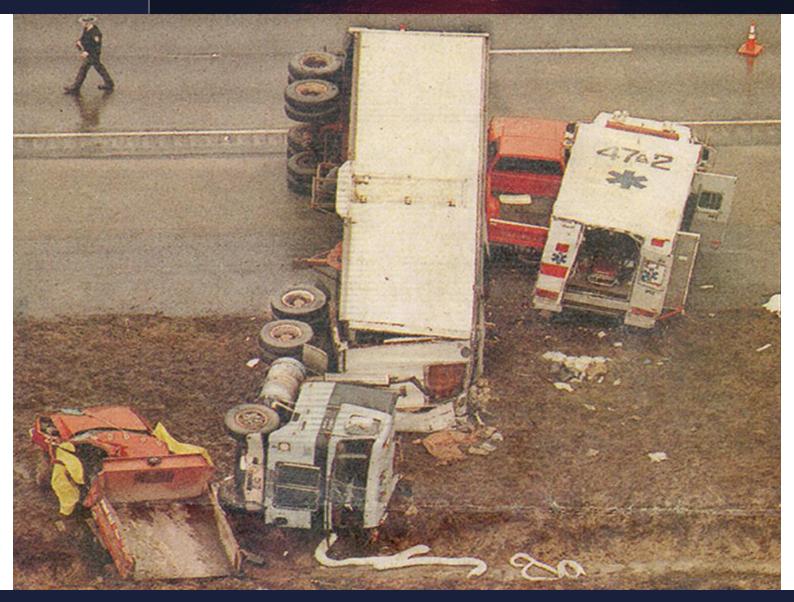
## A "Routine" Incident – Aftermath

- Eight firefighters and two EMTs were struck by the 18-wheeler as it slid into the incident scene
  - One firefighter killed
  - Nine other responders seriously injured

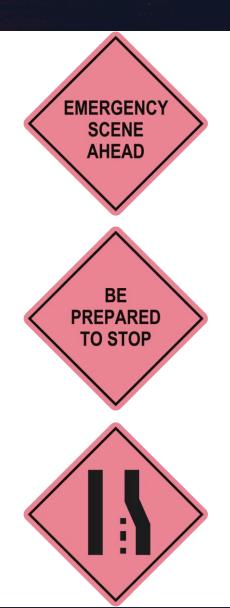
# Advance Warning Signs

- Emergency traffic control warning and guide signs should have:
  - Diamond shape
  - Black lettering and a black border
  - Fluorescent pink background
- The signs come in two sizes:
  - 36" x 36" Low speed, low volume
  - 48" x 48" High speed, high volume
